Vehicle Wheels

EU Roadworthiness Package

POTENTIAL INFLUENCE OF THE HUB SHAPE ON FATIGUE LIFE
PERFORMANCE OF TRUCK AND TRAILER WHEELS

PRESENTATION TO:
THE EUROPEAN
PARLIAMENT'S
COMMITTEE ON
TRANSPORT AND
TOURISM (TRAN)

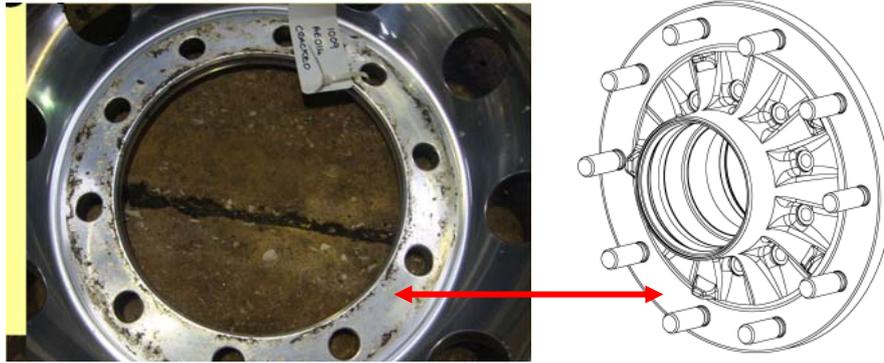
Full circumferential clamping, hub to European wheel standards
Wheel pattern seen in brakedust on the rear of a demounted wheel.

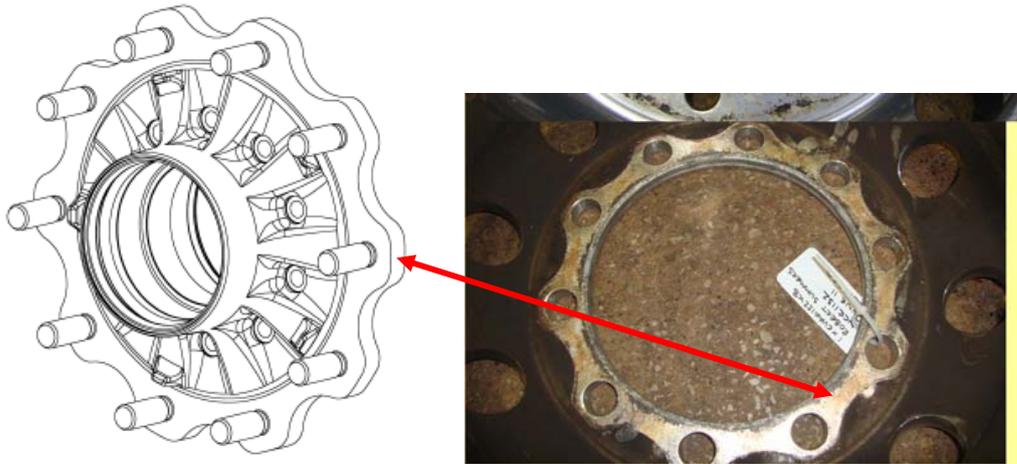
The failure mode is crack starters on the attachment face side along the edges of such a star shape.

Sharp outer edges as characteristic of the star shape design encourage the development of these initial cracks.

Star or Spider hubs, not to European wheels standards
Wheel pattern seen in brakedust on the rear of a demounted wheel.

In order to maximize safety, EUWA strictly recommends for the vehicles equipped with non-circular hubs in the field, that the wheels used on such hubs have to be checked towards cracks on the inner and outer attachment face each 50.000km. In case of crack detection the wheels have to be replaced immediately --- in

such cases also the hubs should be checked with regard to wear out and cracks and if necessary the hubs should be replaced.

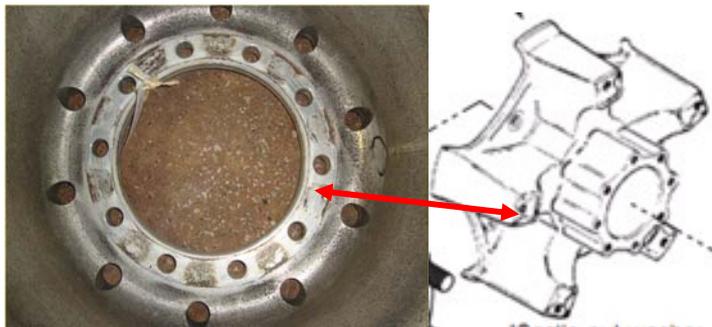
Castellated hub, not to European wheels standards
Wheel pattern seen in brakedust on the rear of a demounted wheel.
