EASA update to TRAN Committee

Brussels, March 18 2019

Actions following the Lion Air crash (1/3)

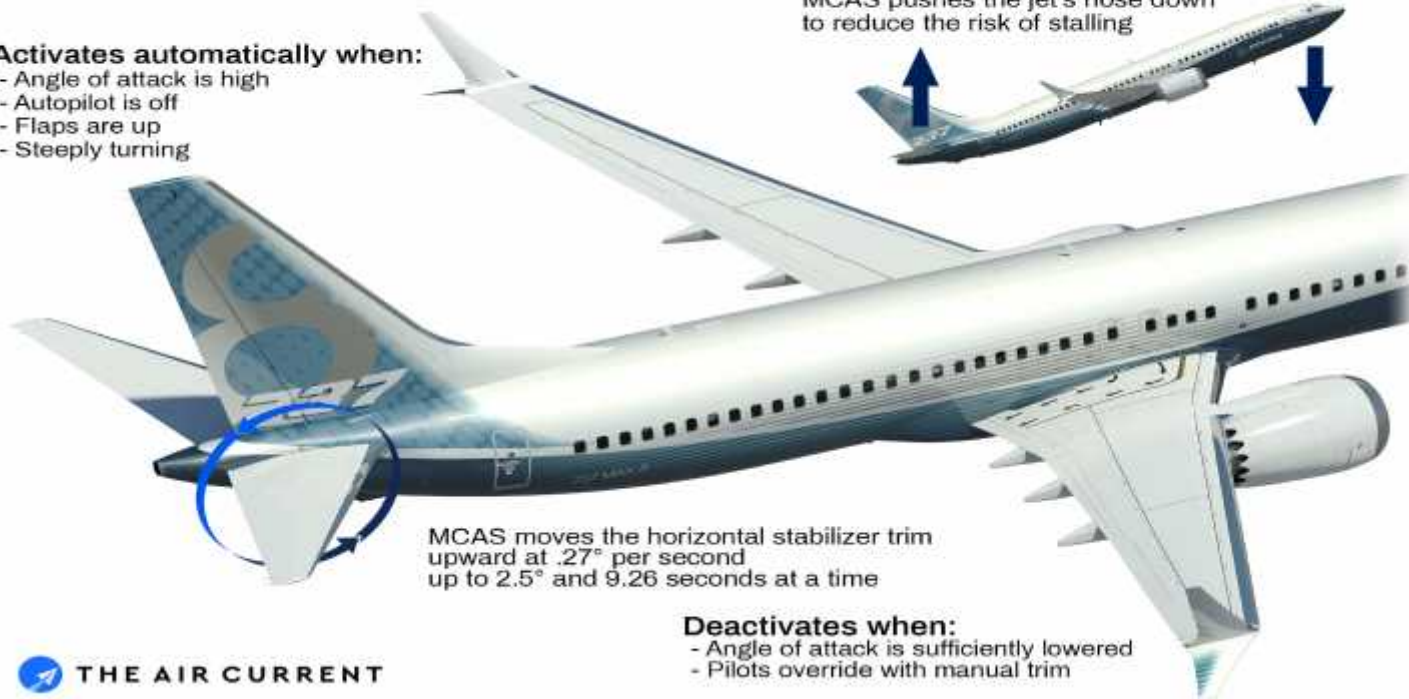
Boeing 737 Max Maneuvering Characteristics Augmentation System

Activates automatically when:

- Angle of attack is high
- Autopilot is off
- Flaps are up
- Steeply turning

MCAS pushes the jet's nose down to reduce the risk of stalling
